The use of Canzee Pumps in the Zinder region of Niger.

**A report of Richard Cansdale's visit to Winrock International, Zinder,
29th August – 11th September 2009.**

**SWS Filtration Limited, Hartburn, Morpeth, Northumberland, NE61 4JB, U.K.
Tel. +44 (0) 1670 772214 email. rcansdale@gmail.com**

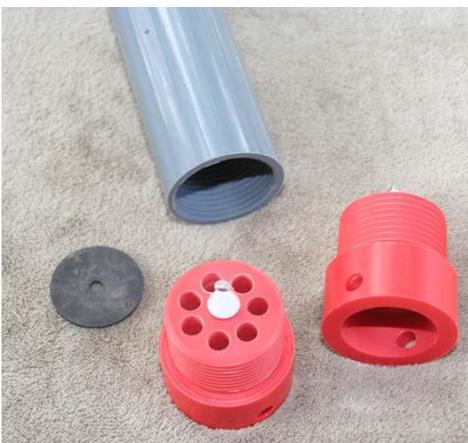
2. The tiny **cone** which holds the rubber disc in place is injection molded for SWS in the UK.
 3. The special **stainless steel pin** which holds the cone onto the valve body is bought in the UK

4. The **rubber disc seal** which sits on top of the valve is cut from old inner tube (vehicle tyre.)

Except for the rubber discs which are cut from widely available inner tube (tyre) rubber, all the other items are harder to source locally. We were told that solid pvc bar from which the valve bodies are made can be obtained in Kano, although we did not find any. If proved to be difficult to source it could be sent from the UK.

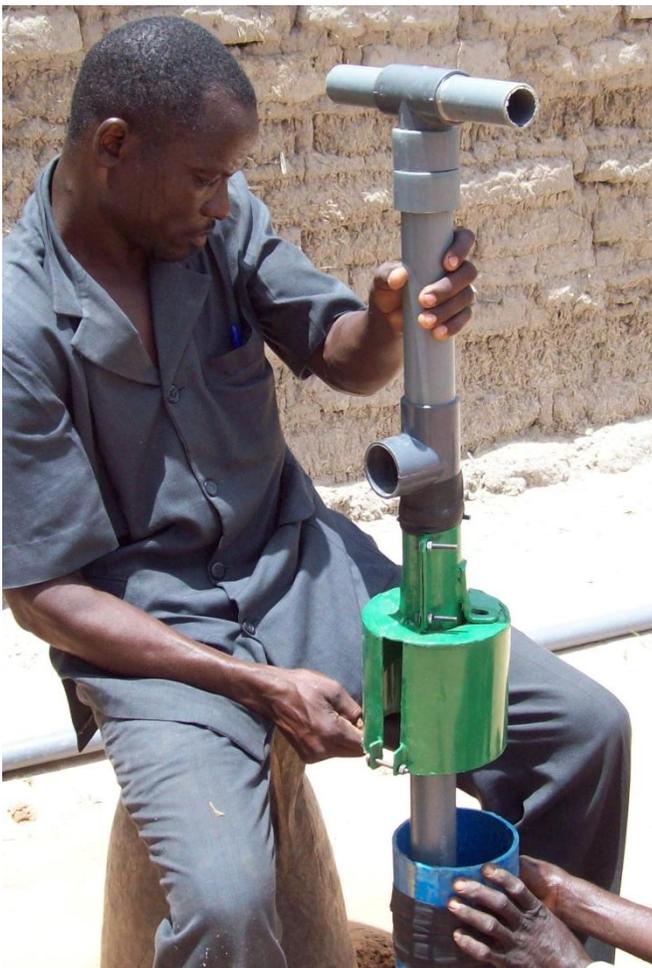
Suggested construction of a Private Canzee Pump.

The plunger assembly:-

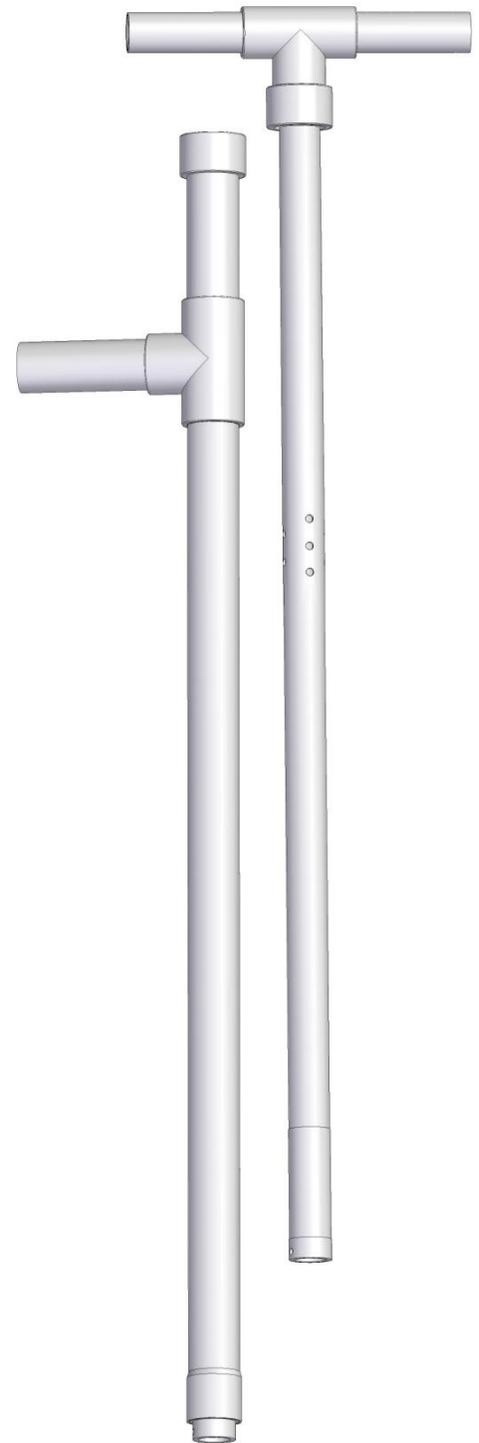
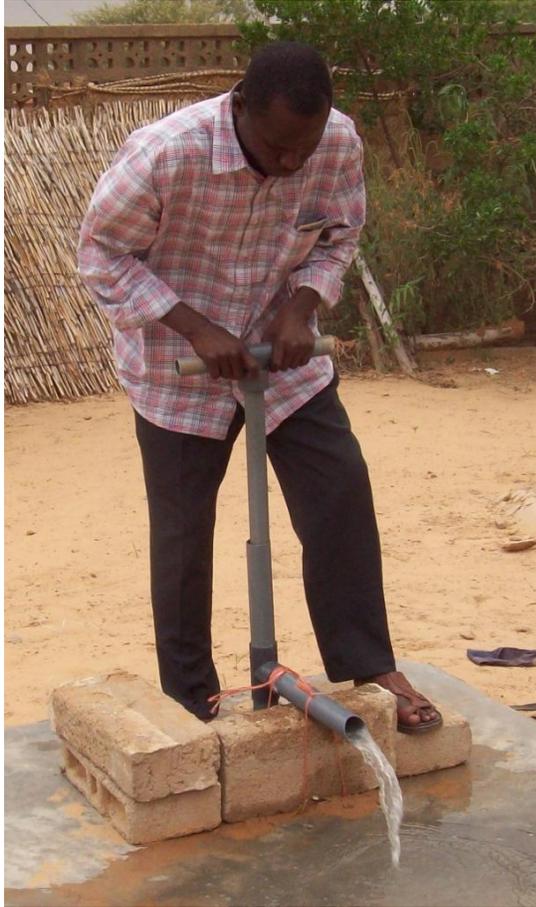
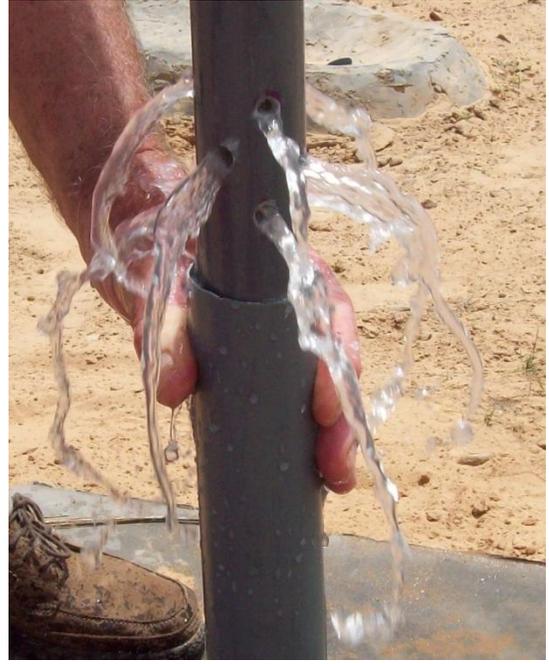
Unlike the village Canzee Pump in which a venting plug is locked onto the bottom of the stainless steel rod, venting holes can be cut directly into the wall of the plunger pipe, and in place of a conventional handle, the user can either grip the top of the plunger pipe directly, or a pvc 40mm Tee can be glued onto the top of the plunger pipe to create a handle.

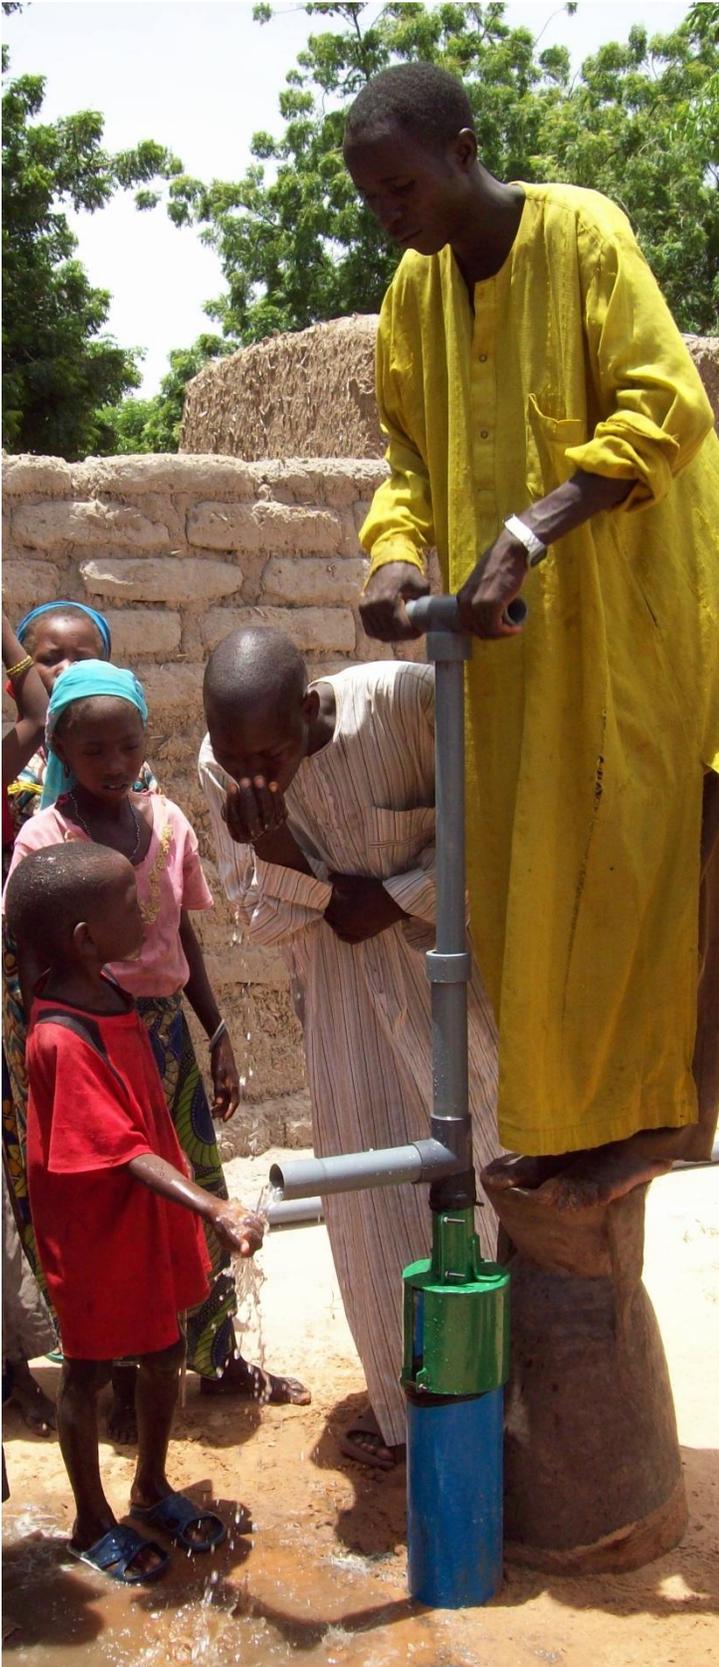
On Tuesday 8th September we took a simple Canzee Pump to the village of Sara Sara, where an Elhadj Mahamadou Adamou had paid for his own well to be sunk in his own compound.

Using the clamp welded by Sani, the pump was mounted directly onto the well casing and clamped in place. At the time of the installation no cement plinth had been cast, so test pumping was effected by standing on an upturned mortar (The large wooden vessel in which corn or millet is pounded).

The pump performed precisely as hoped, yielding as much water as the recently installed villages pump one hundred metres away.
